Response of a stream ecosystem to debris flows

A case study following the recovery of a recently harvested headwater riparian and stream ecosystems after extreme rain, flooding and debris flows.

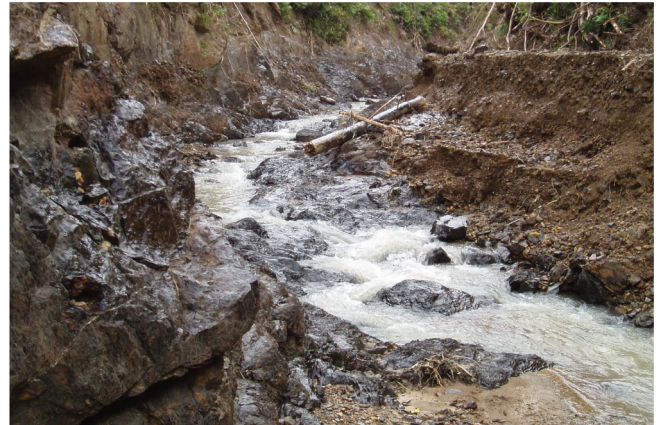
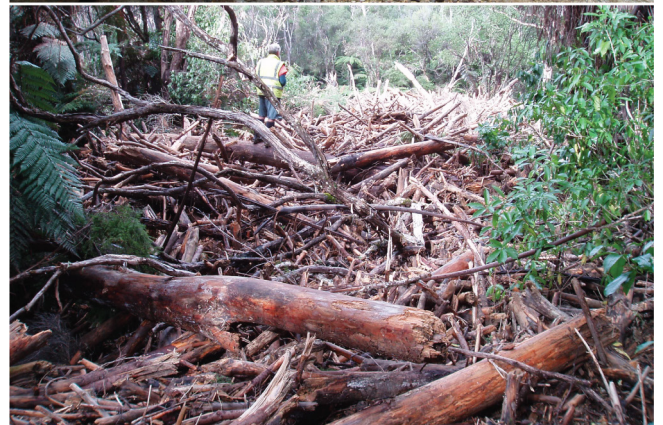
Debris flows scour out headwater stream channels (top) and depositing the material downstream (bottom).

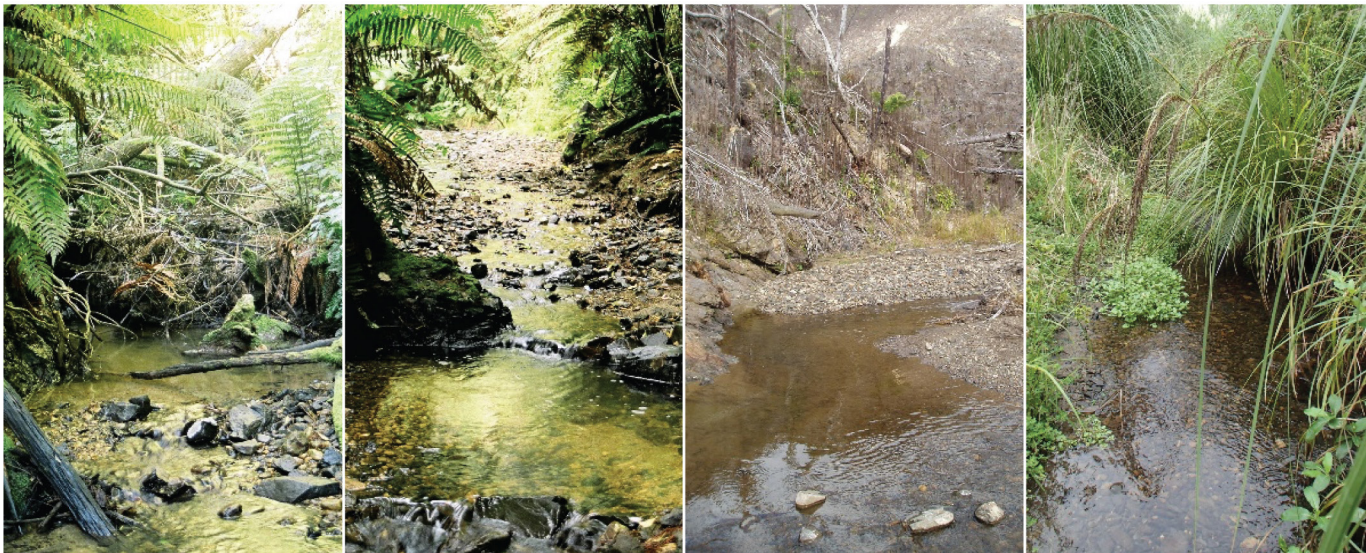
Pool habitat before harvesting and the extreme weather event.

Pool habitat immediately after the event and five years later.

The scouring effect of debris flows also reduced the number of pools, including nearly all the pools formed by stable wood in the streams. The number of pools recovered to varying degrees in the first five years. Although pools formed by wood were scarce, some in-stream and overhead cover was provided by the reestablishing riparian vegetation.

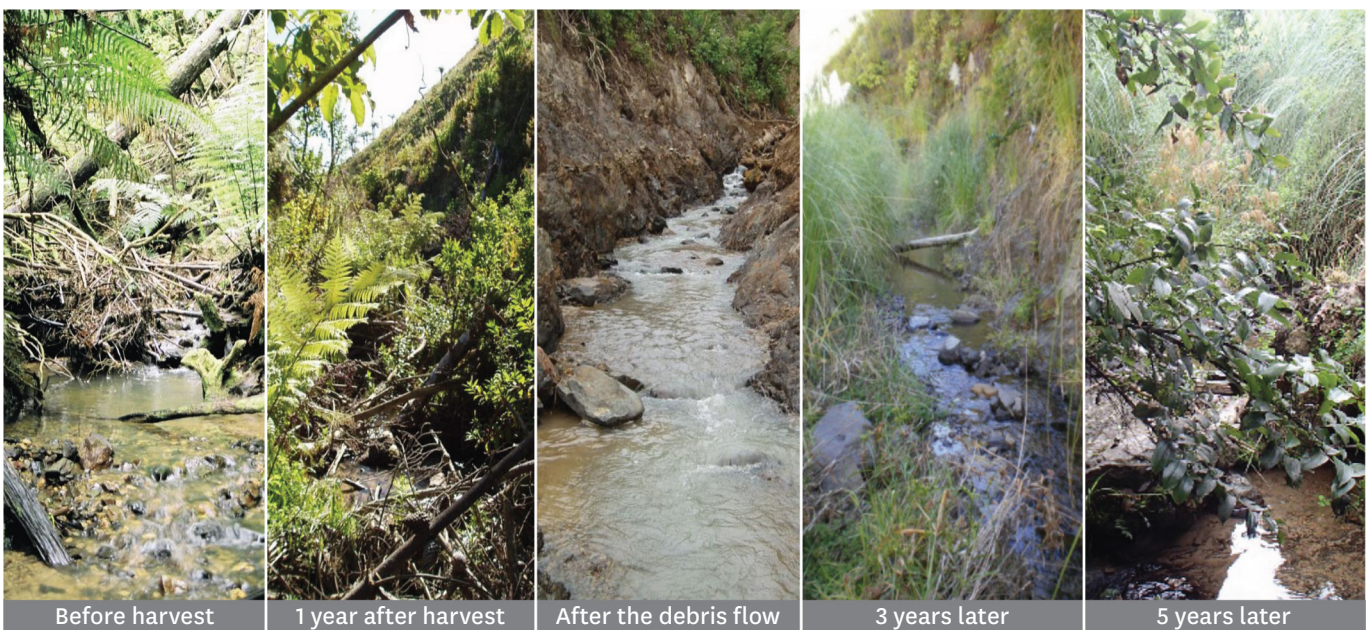
Before harvest

1 year after harvest

After the debris flow

3 years later

5 years later

The overhead cover and shade provided by the recovering riparian vegetation was a key factor influencing in-stream recovery.

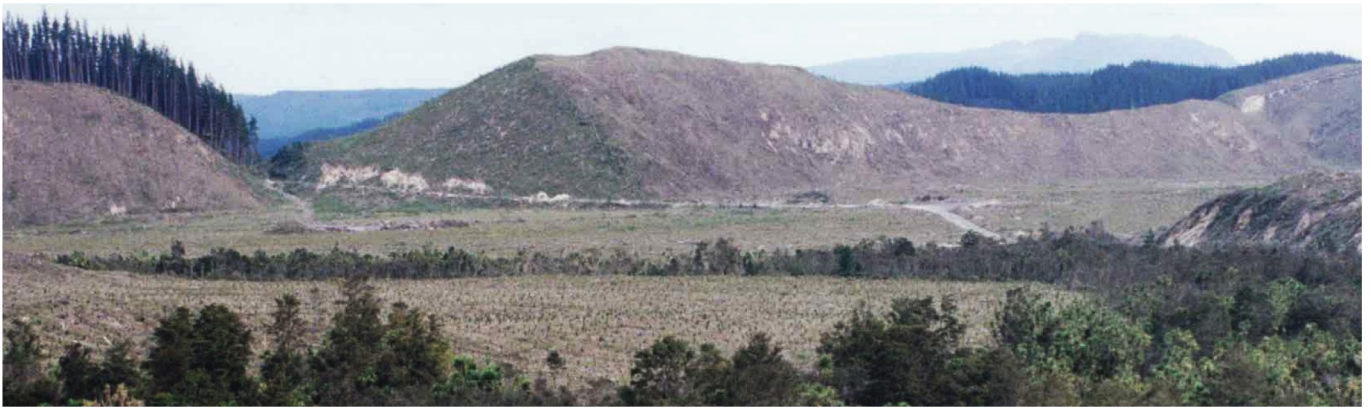
Retention of an intact riparian margin during and after harvesting.
